Transportation Safety Board
of Canada

MARINE INVESTIGATION REPORT
M04L0099

COLLISION

BETWEEN THE PLEASURE CRAFT *MONDISY*
AND THE CONTAINER SHIP *CANADA SENATOR*
OFF SAINT-NICOLAS, QUEBEC
11 AUGUST 2004

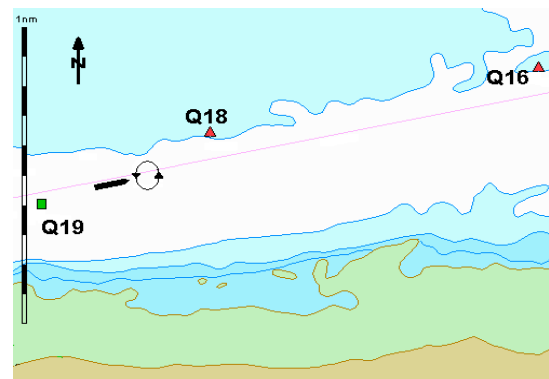
Figure 1. *Mondisy* track (not to scale)

A sailboat making unusual movements caught the attention of an observer located high on an overlooking cliff in Saint-Nicolas. The *Mondisy* was observed circling to port, that is counterclockwise, for at least 15 minutes, and possibly for as long as 25 minutes before the collision.

The movement of the sailboat was reported as being unusual, but many pilots report similar experiences with pleasure boats. To the bridge team who observed the *Mondisy* on board the *Canada Senator*, the sailboat was moving back and forth across the river. A shore-based observer very close to the collision site and high on the overlooking cliffs indicated that the sailboat had in fact been circling to port (counterclockwise) for at least 15 minutes before the collision. The *Mondisy* was also drifting down river with the ebbing tidal current at between 2 and 3 knots.

From the nearby cliffs and looking down at the *Mondisy*, the sailboat's true movement could be observed, that is circling. However, from a distance such as on board the *Canada Senator*, the circular movements of the *Mondisy* appeared as a zigzag manoeuvre. Repeatedly turning in circles is consistent with either a mechanical malfunction related to the steering, or the helm simply being left unattended for some time before the collision. There was no sign of activity on deck during the 15-minute period before the collision.
